Property Inspection Report

PROPERTY INSPECTION REPORT

Concerning: 18015 Navajo Trail Dr, Spring TX, 77388
(Address or Other Identification of Inspected Property)

By: Habib Othman, License # 22007 3/18/2019
(Name and License Number of Inspector) (Date)

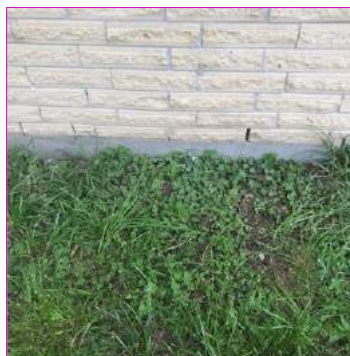
- Due to parging applied to the foundation wall, the Inspector was able to see if there were visible cracks. Parging is a mortar coat or finish coat that is applied to the finish surface of the foundation to act as a finish coat to improve the appearance. Parging can be applied to new or existing foundation.

Foundation parging

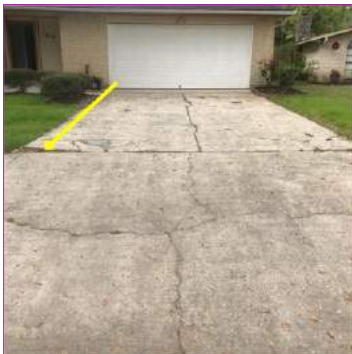
Trip hazard

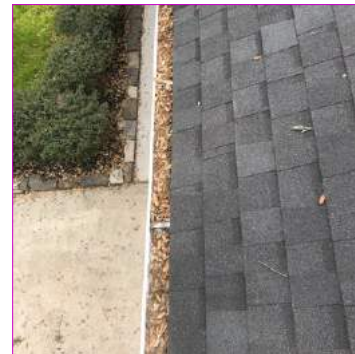
Gutter debris

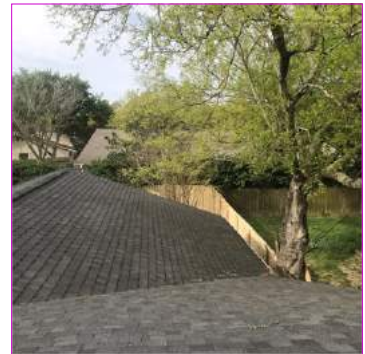
- The asphalt shingle roof can be damaged by the overhanging tree branches rubbing against the roof. The Inspector recommends that all tree branches be cut back so that they do not overhang the roof. All work should be performed by qualified contractors.

Monitor and trim tree branches

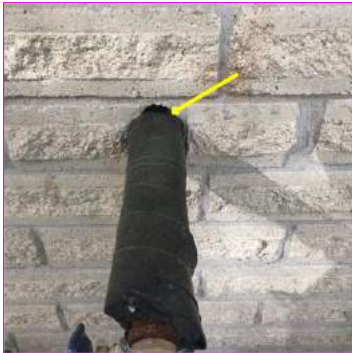
- Pipes penetrating exterior walls left gaps that needed to be sealed with an appropriate sealant to prevent moisture and insect entry. All work should be performed by a qualified contractor.

Seal wall penetration (font facade)

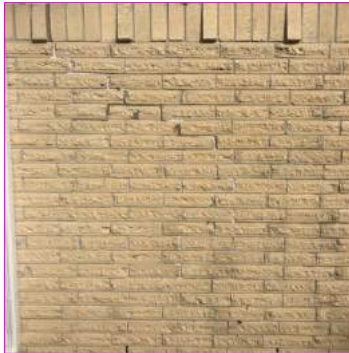
- Brick exterior walls had repaired stepped cracking visible in mortar joints. This condition is a structural concern and can have a variety of causes, often connected with soil movement.

Repaired step cracking (left facade)

However, the Inspector did not observe any cracks in the foundation. Inspector recommend monitoring the crack if it widens.

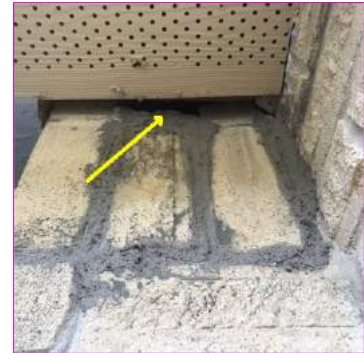
Seal gap

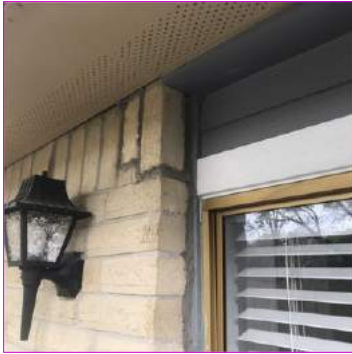
Repair noted

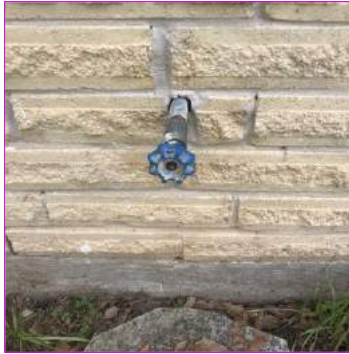
Seal wall penetration (back facade)

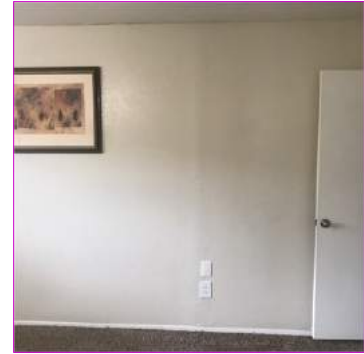
- Signs of previous drywall repair were visible in the master bedroom.

Visible patching (master bedroom)

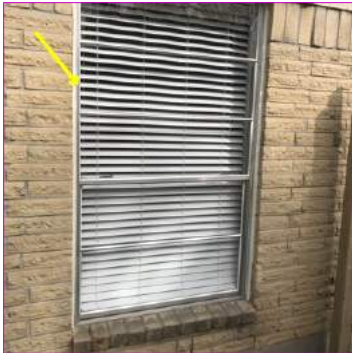
- Window trim had gaps that should be filled with an appropriate sealant by a qualified contractor to help prevent moisture and insect entry.

Seal gaps in window trim (left side)

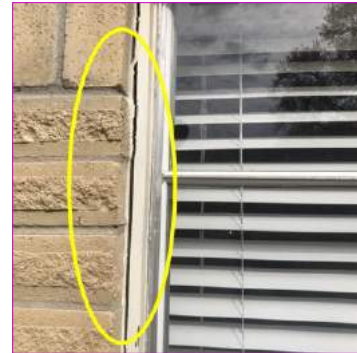
Seal gaps in window trim (zoomed)

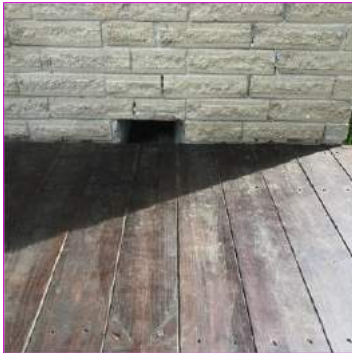
- At the time of the inspection there was a missing ash cleanout door. A missing chimney cleanout door or any other hole in the flue means that there is a fire safety hazard (sparks or ashes falling out onto the basement floor) and also that it is impossible to control the draft in the flue.

Missing ash clean out door
(Chimney)

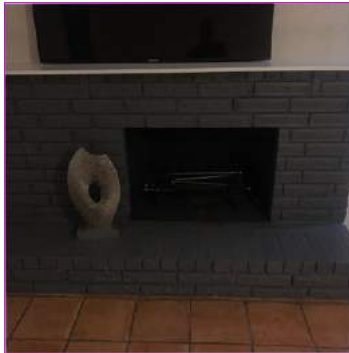
- The fireplace lacked an ember barrier. This condition is a potential fire hazard as it may allow hot embers to be deposited on the combustible floor-covering material. The Inspector recommends providing a means for containing fireplace embers such as a screen.

Wood Fireplace

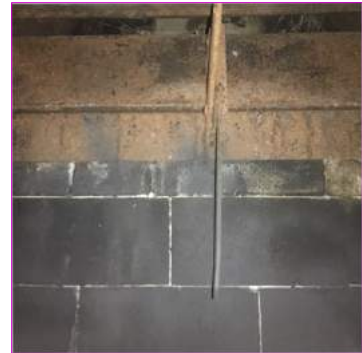
- The damper of the wood-burning fireplace in the main floor family room appeared to be inoperable at time of the inspection. This condition may prevent proper exhaust of the toxic products of combustion to the home exterior and allow them to enter the living space. The Inspector recommends correction by a qualified HVAC contractor.

Inoperative damper

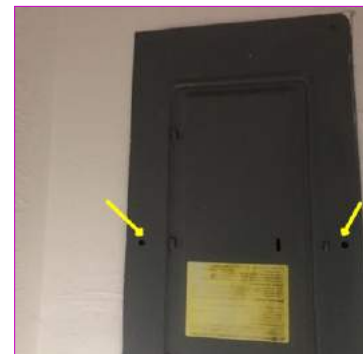
Missing front cover screws

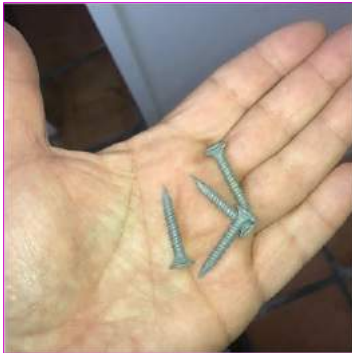
Inappropriate screws

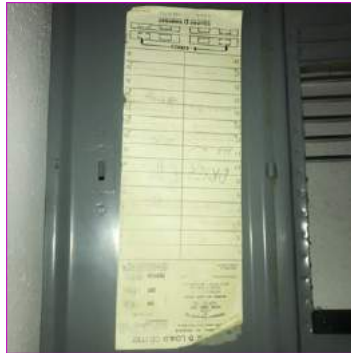
- Markings on the Circuit Directory of the service panel designed to identify individual branch circuits appeared to be old and may be outdated. The Inspector recommends that individual branch circuits be accurately identified and clearly labeled so that individual branch circuits can be shut down quickly in an emergency.

Obsolete directory

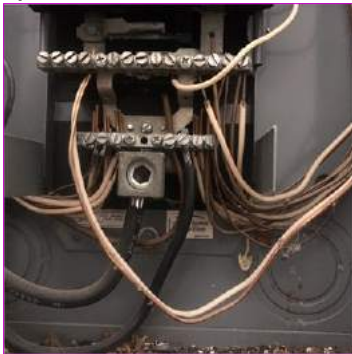
- In the service panel, multiple neutral conductors were installed in a single hole in a bus bar. This condition is improper. Widely-accepted common safety standards mandate that only one neutral conductor terminate in each hole in a bus bar. The Inspector recommends correction by a qualified electrical contractor

Multiple neutral in one hole

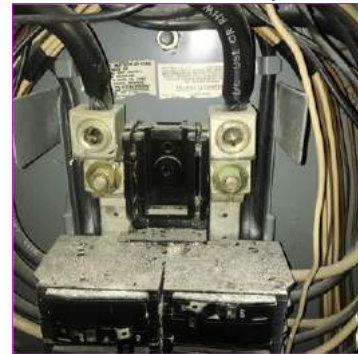
Aluminum service wires missing anti oxidant

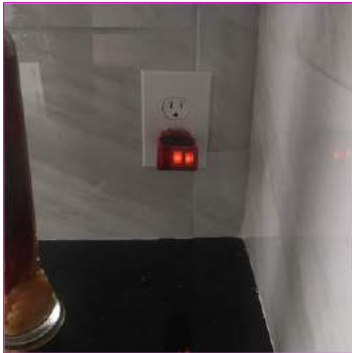
Receptacle not GFCI (kitchen)

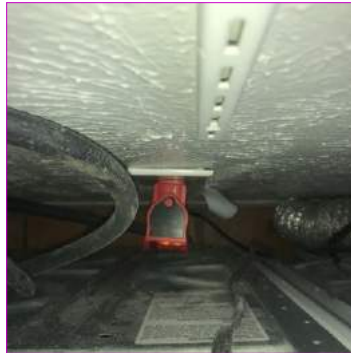
Receptacle not GFCI (laundry)

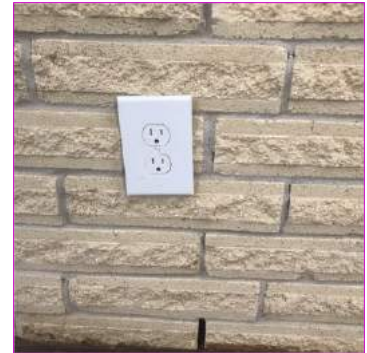
Exterior receptacle not GFCI (back side)

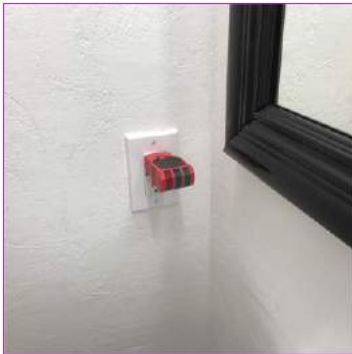
Inoperative GFCI receptacle (half bathroom)

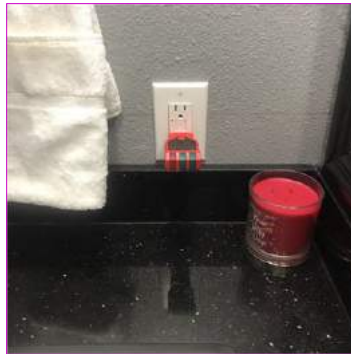
Inoperative GFCI receptacle (master bathroom)

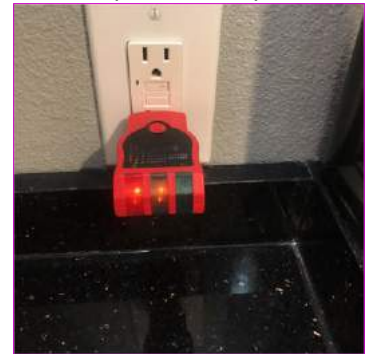
GFCI hot/neutral reversed (hallway bathroom)

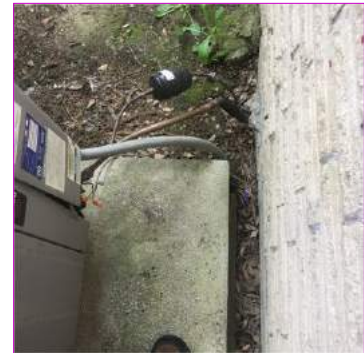
Missing insulation

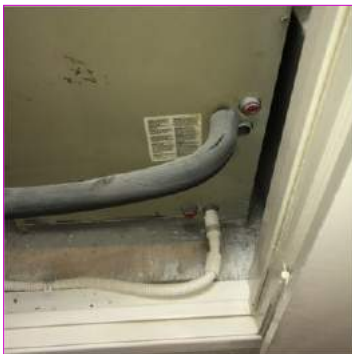
• The cooling system evaporator coil had no secondary condensate drain installed. If the primary condensate drainage system should become non-functional, this condition could result in moisture damage to home interior materials.
 The Inspector recommends that a secondary drainage system such as a pan with an overflow routed to discharge properly be installed by a qualified HVAC contractor.

Missing secondary condensate drain

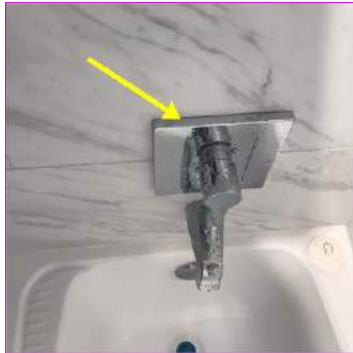
- Sealant where the spigot meets the wall had sections of missing sealant which may allow damage from moisture intrusion of the wall assembly. The Inspector recommends correction by a qualified contractor.

Seal

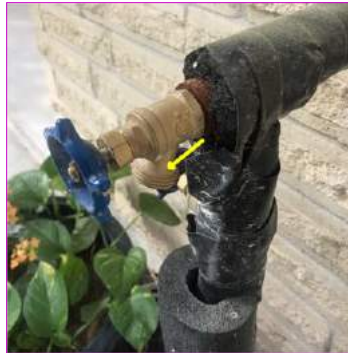
- An exterior faucet was missing an anti siphon device on exterior hose bib. This device prevents non-potable water from being siphoned back into the potable water supply. Correct as needed.

Missing anti siphon

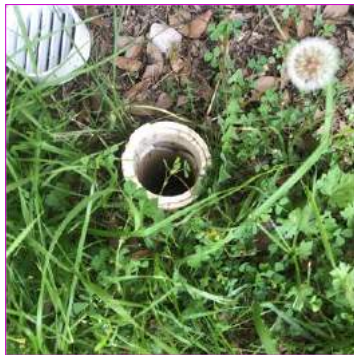
- A clean out cover had a broken cover. The Inspector recommends repair by a qualified contractor.

Broken clean out cover (back side)

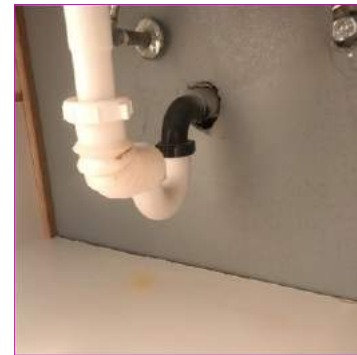
- Inappropriate drain type "accordion pipe" used in the drain pipe. Drain pipes should have smooth walls to promote proper drainage and prevent clogs. Contact a qualified plumbing contractor to replace drain pipes with proper material."

Accordion pipe (hallway bathroom)

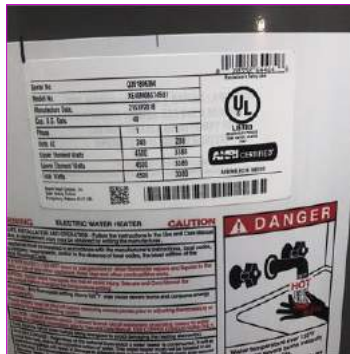
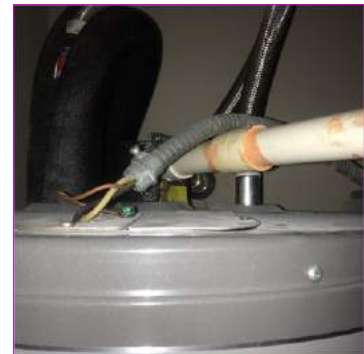
Exposed wires

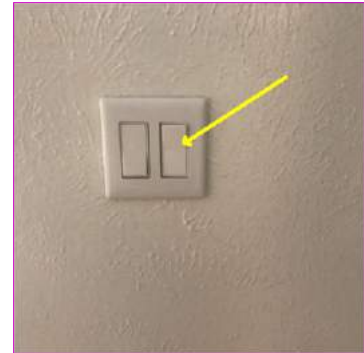
Inappropriate wiring. Switch operates garage light and garage opener (hallway)

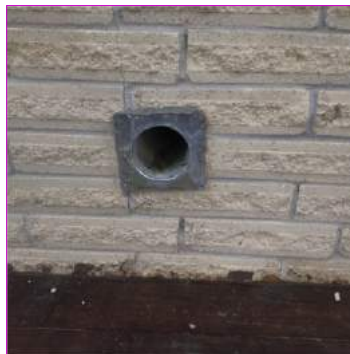
- The dryer vent was missing the exterior cover or screen. This condition may allow animal entry or the accumulation of debris related to animal nesting. The inspector recommends installation of a proper cover by a qualified contractor.

Dryer vent missing screen
