Bulls Eye Home Inspection, PLLC

Phase Inspection Report

Date of Inspection: 3/29/2019 Time: 10:00 AM
Order ID: 509

Pre-Drywall Checklist

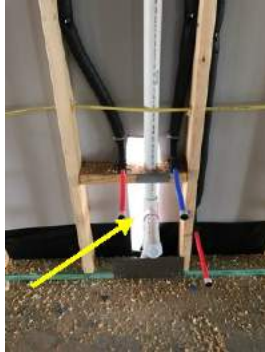
Holes/tears were observed in the weather resistive barrier. We recommend having them repaired per the manufacturer's instructions. See section R703.2. This was noted on the

Visible gap in the WRB sheathing

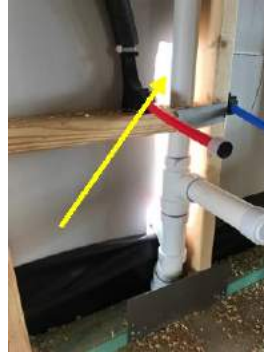
Visible gap in the WRB sheathing

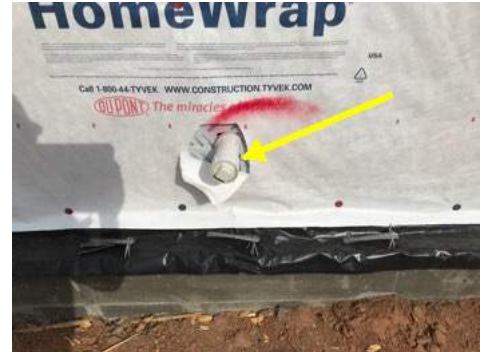
Tape around pipe penetration

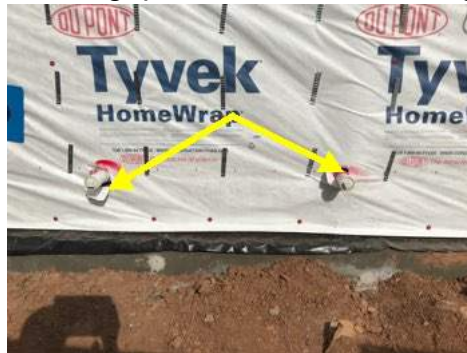
Tape around pipe penetration

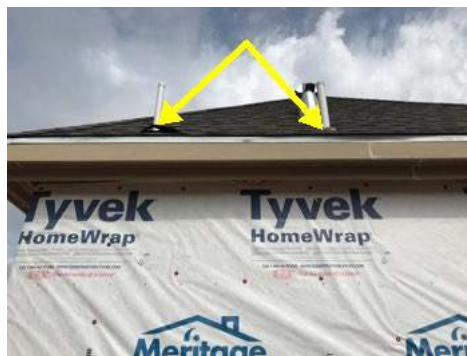
One or more plumbing vent at the roof was missing a flashing boot. We recommend having this repaired to prevent intrusion into the attic space.

Missing plumbing boot

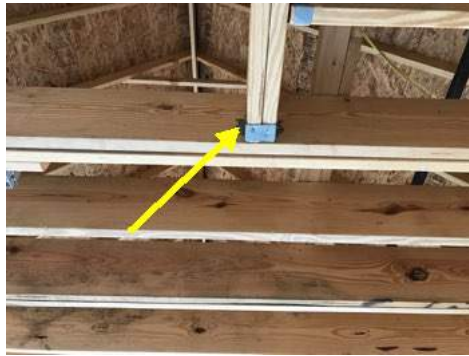
Joist hangers were lacking fasteners (nails). Each hole in the hanger should have a fastener per manufacturer's instruction. We recommend repair.

Missing nail floor joist support (garage)

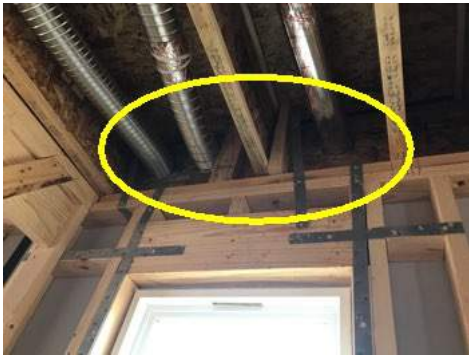
Seal around wall penetration

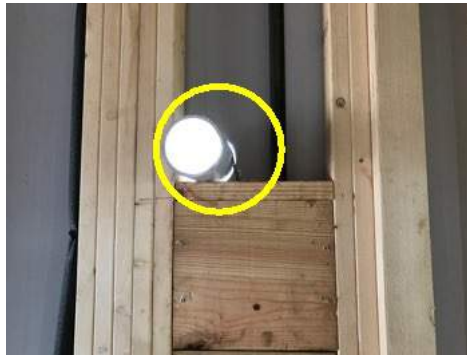
Seal around wall penetration

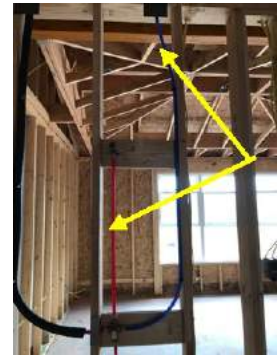
One or more PEX pipe were missing insulation.

Missing PEX pipe insulation

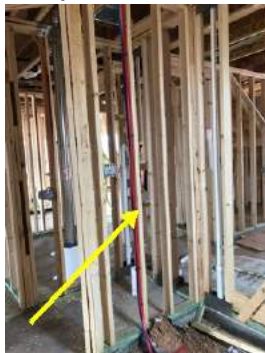
Missing PEX pipe insulation

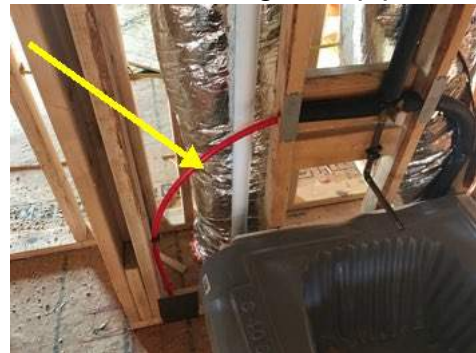
Missing PEX pipe insulation

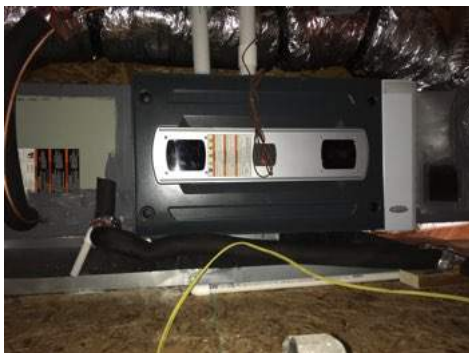
High Efficiency electric furnace ok

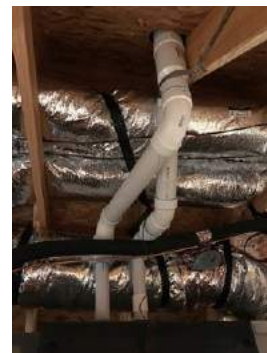
HVAC flue ok
