# *Bulls Eye Home Inspection, PLLC*

## Phase Inspection Report

Date of Inspection: 2/25/2019 Time: 11:00 AM  
Order ID: 441

# Pre-Pour Checklist

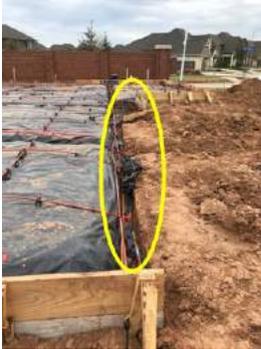
Missing formwork

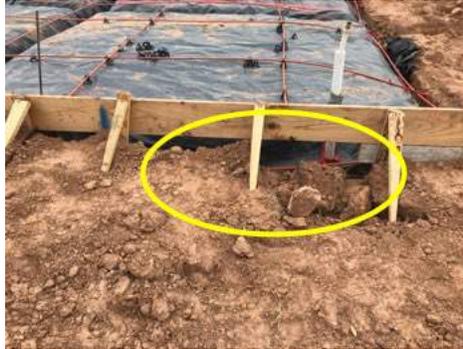
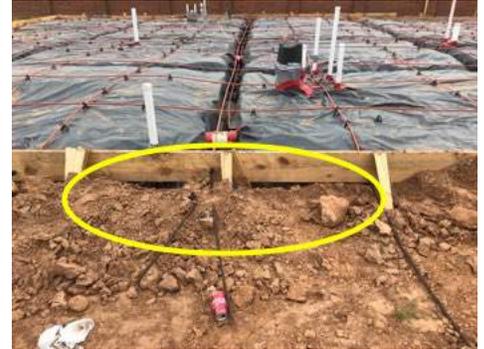
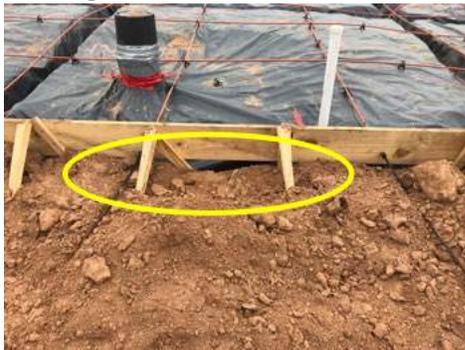
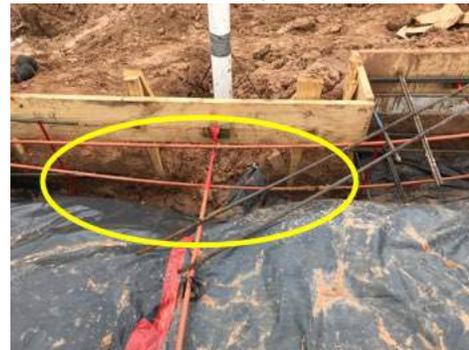
Large gaps were observed under the form boards. We recommend having this corrected to prevent the concrete from flowing out during its placement.

Gap under formwork

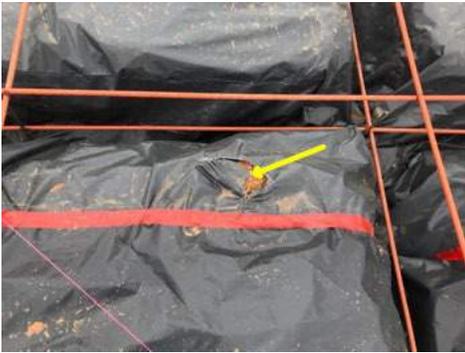
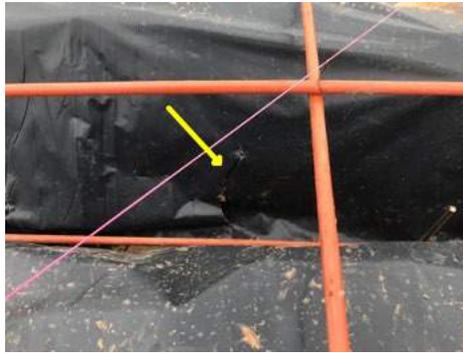
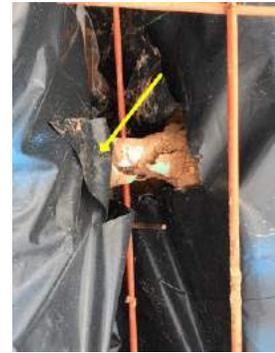
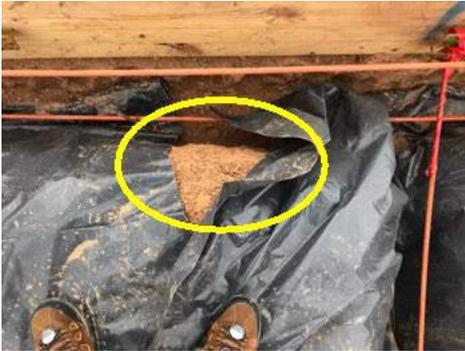
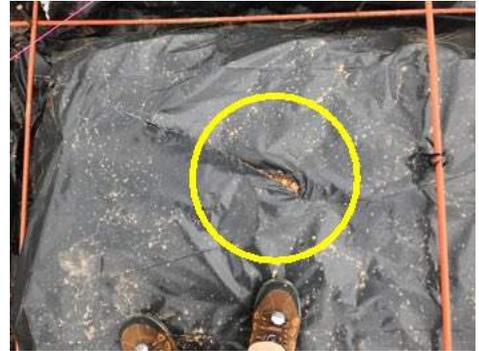
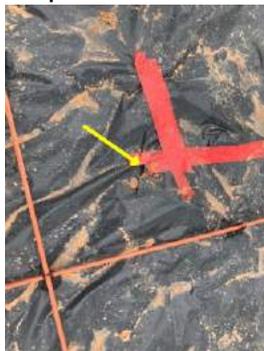
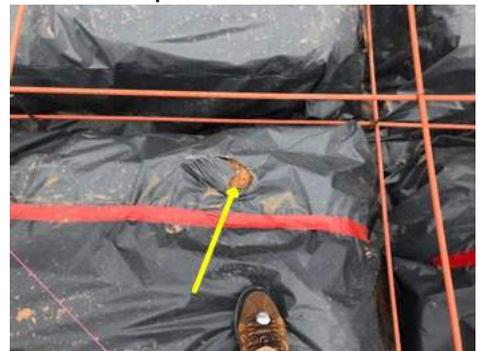
The vapor barrier has multiple holes/tears/opening at overlapped joints/under the drain pipes or on side beams etc... All opening in the barrier should be taped prior with a manufacturer approved tape prior to placing the concrete.

Vapor barrier hole

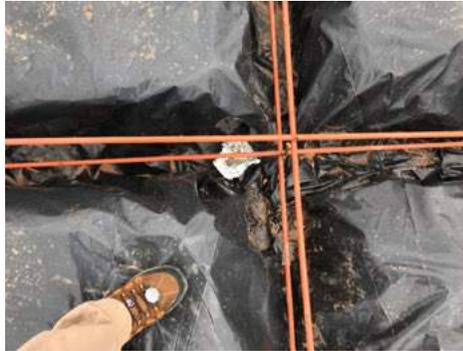
Debris was found in the beams and will create an air pocket when the concrete is placed. This condition should be corrected with removal of all debris.

Debris

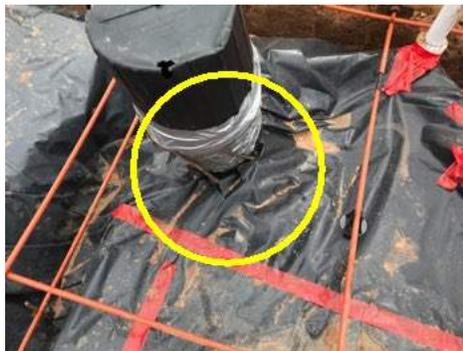
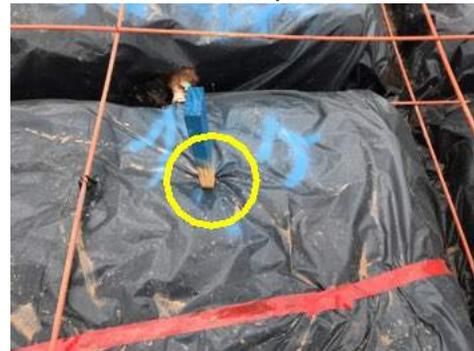
Wrap penetration

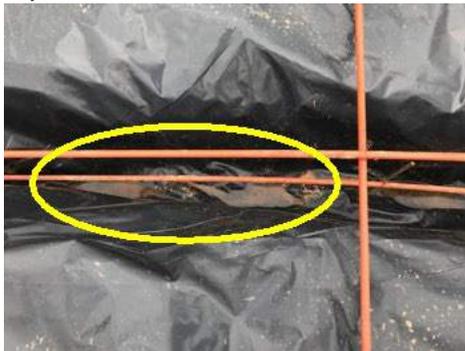
Water was found in the beams and will create an air pocket when the concrete is placed. This condition should be corrected with removal of all water.

Water in beam

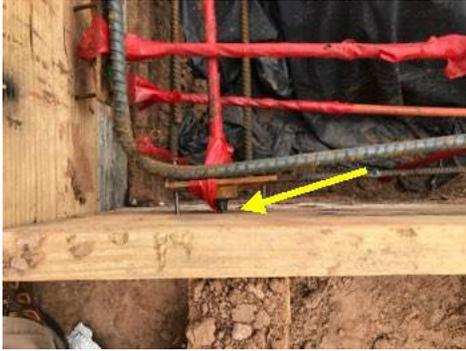
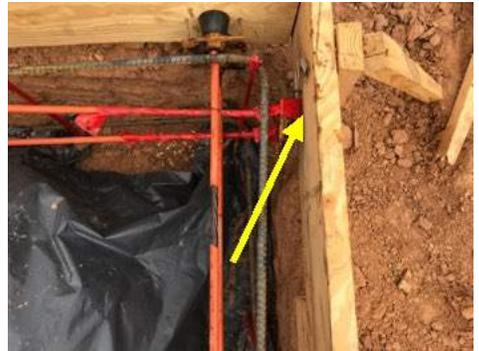
One or more tendon was found to be in contact with the form work. A 3/4 of inch gap should be left between the tendons end and the formwork. This should be corrected prior to placing the concrete.

Inadequate gap at cable end

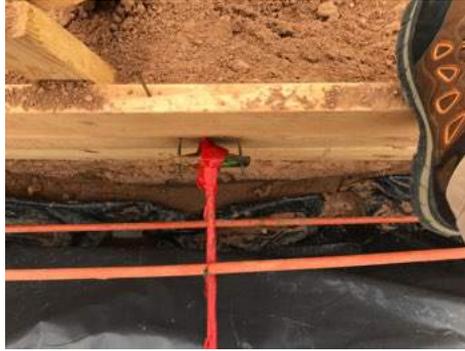
One or more tendon had the cable end taped. There should be a minimum of 12" unwrapped on the tendons fixed end. This should be corrected prior to placing the concrete.

wrapped tendons at the fixed end

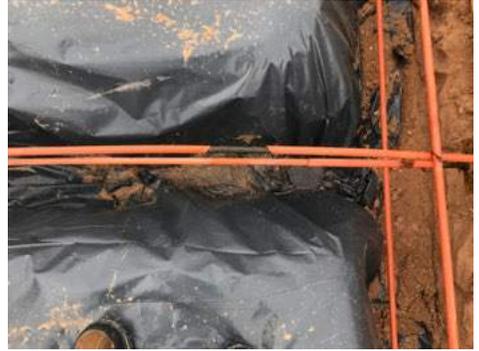
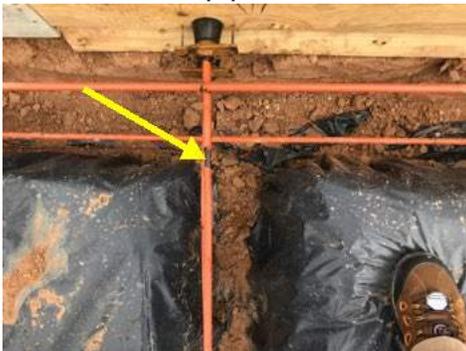
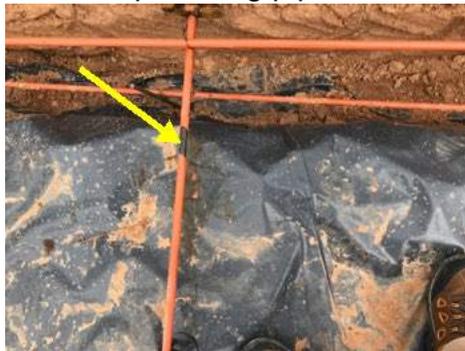
The sheathing on multiple tendons was damaged/ cut short and left the strands exposed to being in contact with the concrete. The tendons should be greased and taped prior to placing the concrete.

Sheathing tear

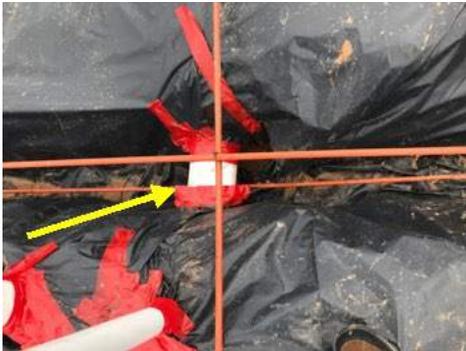
A tendon was found to be in contact with a PVC pipe (drain/vent). This could put stress on the

pipng when the tendons are put under tension, risking damage to the piping. This should be corrected prior to placing the concrete.

cable running below plumbing pipe

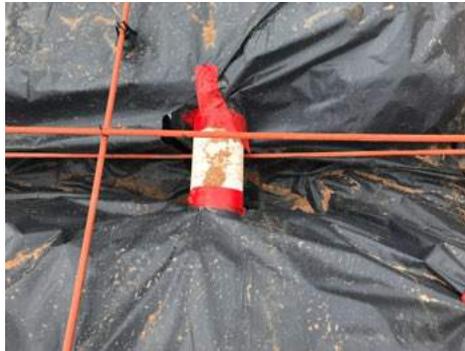
Tendons installed below the plumbing pipe.

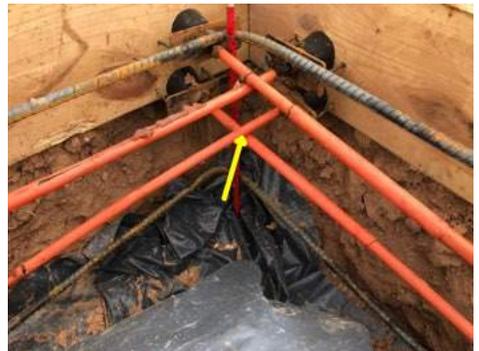
Not tied

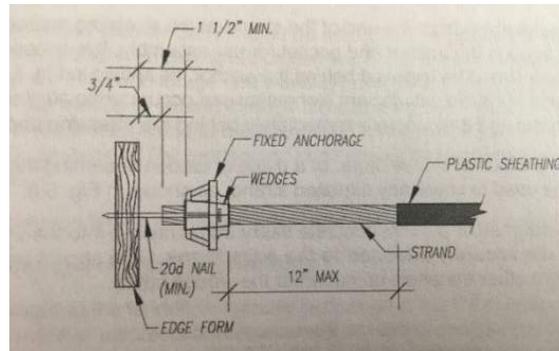
Fixed end assembly installation

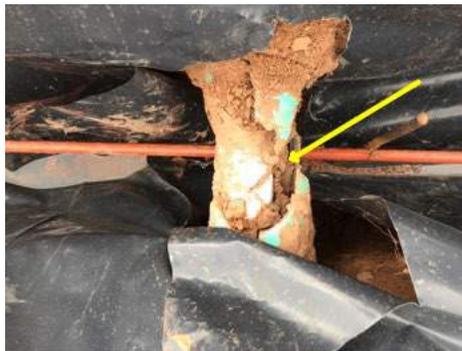
A waste pipe sleeve was broken making the drain line vulnerable and unprotected from the foundation structural load transfer. This should be repaired prior to pouring the concrete. Any pipe installed within or under a footing or foundation wall must be protected structurally from any transferred loading from the foundation wall or footing. A relieving arch or a pipe sleeve can be used to provide this protection. Where a sleeve is used, it must be two pipe sizes larger than the enclosed pipe. This space will allow for differential movement of the pipe. (See Figure P2603.5. International Residential Code for One- and Two-Family Dwellings P2603.5 Pipes through footings or foundation walls.) Any pipe that passes under a footing or through a foundation wall shall be provided with a relieving arch; or there shall be built into the masonry wall a pipe sleeve two pipe sizes greater than the pipe passing through.

Broken sleeve
